Our Journey - *From the Eye to the Lens*

# RVI: Remote Visual Inspection

# Test Separator RVI

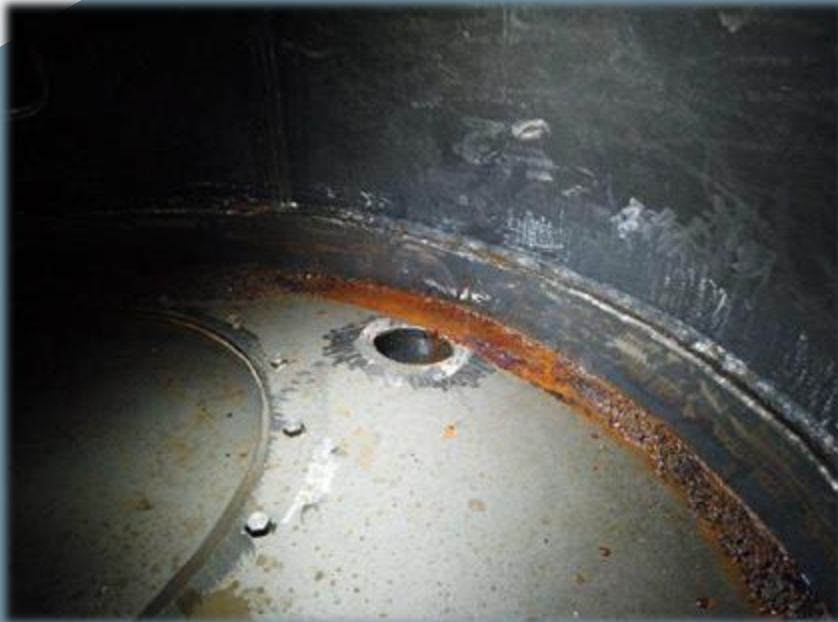
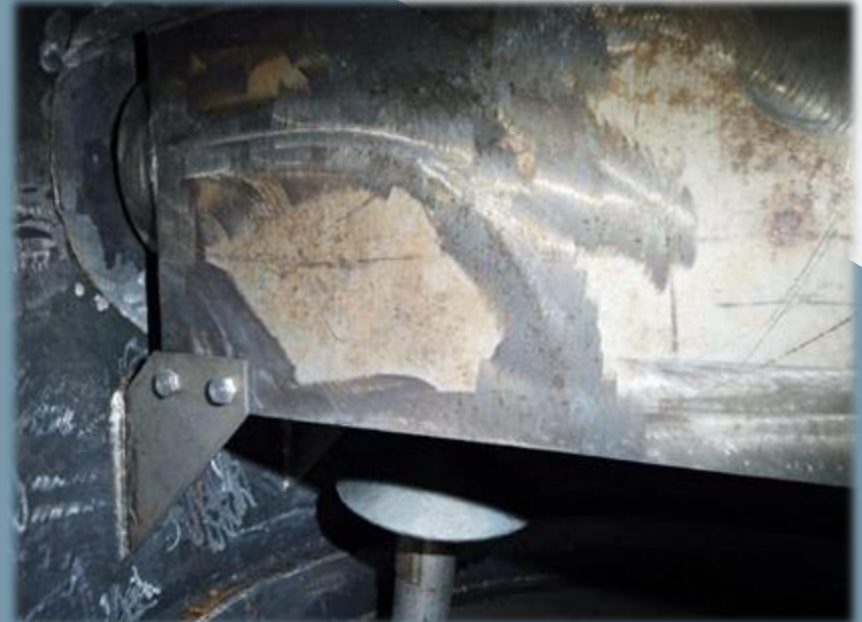
# Results – above Baffle Plate

DJI Osmo stills were surprisingly clear given the cost of the camera

- Images comparable to close visual inspection
- Small size, low cost and easy to use.

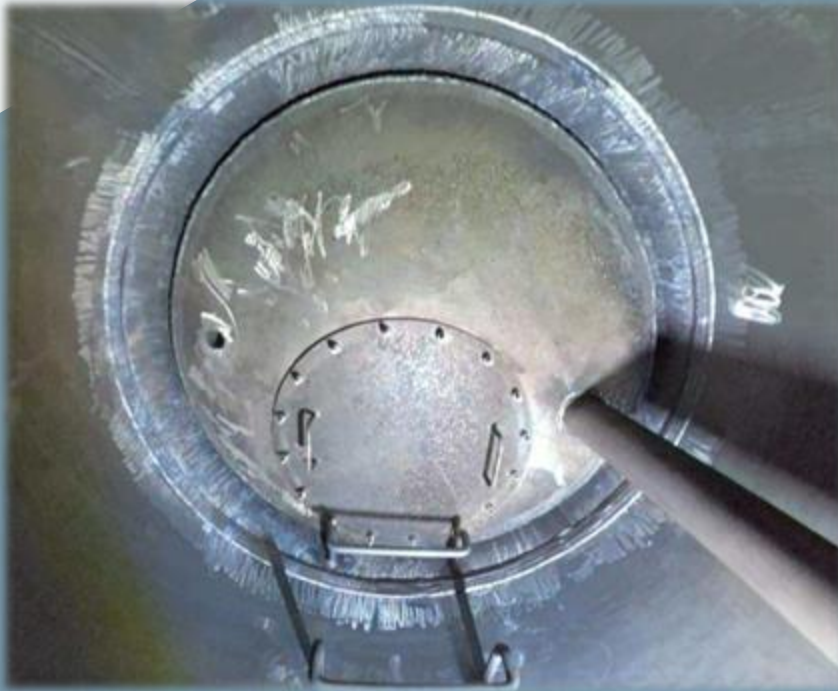
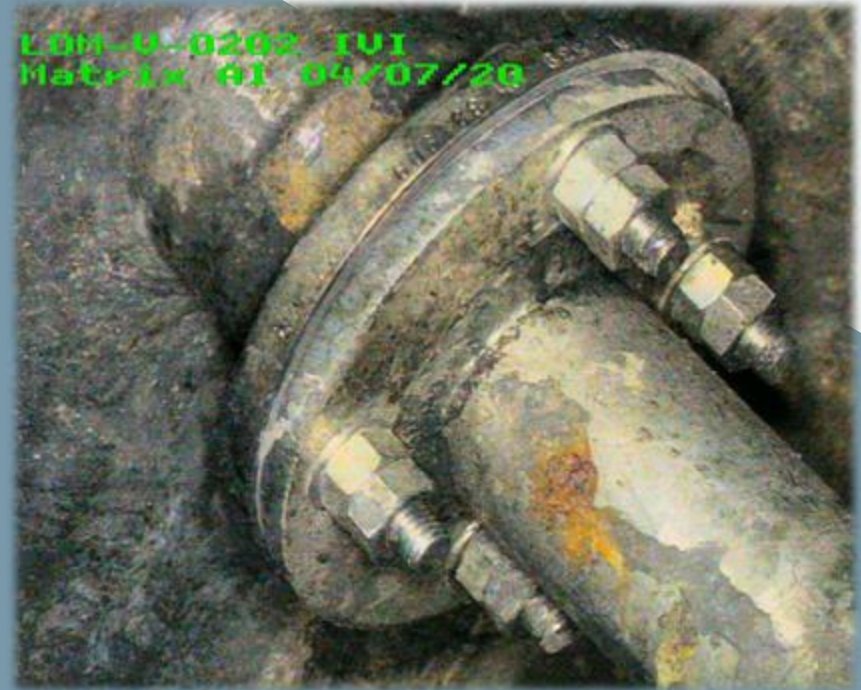
# Results – below Baffle Plate

Dekra VT360 imagery not as clear, however this may be due to the small diameter of the vessel

- May be more useful in larger vessels

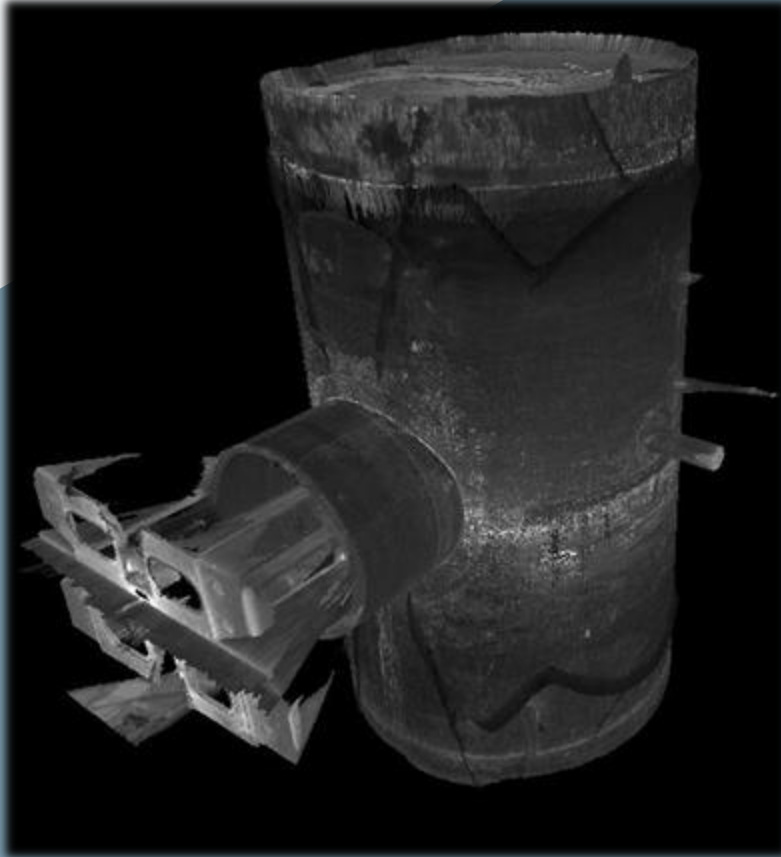
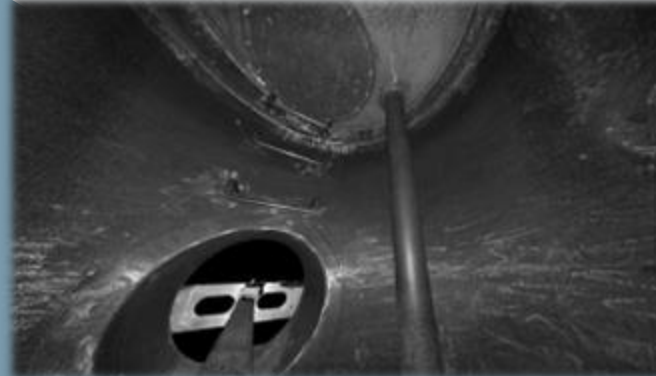
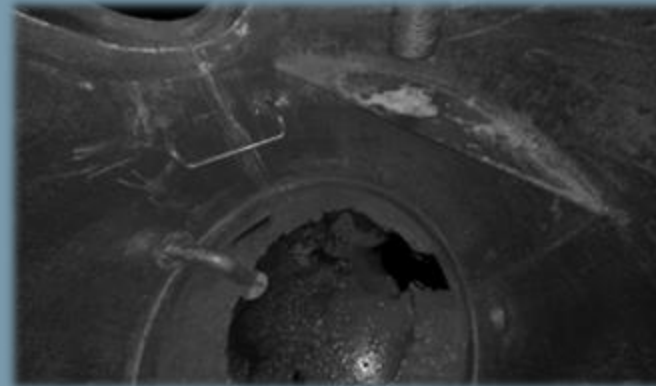
# Laser Scan – 3D Model – Test Separator

3D model of the vessel produced

High degree of noise due to stainless steel internals

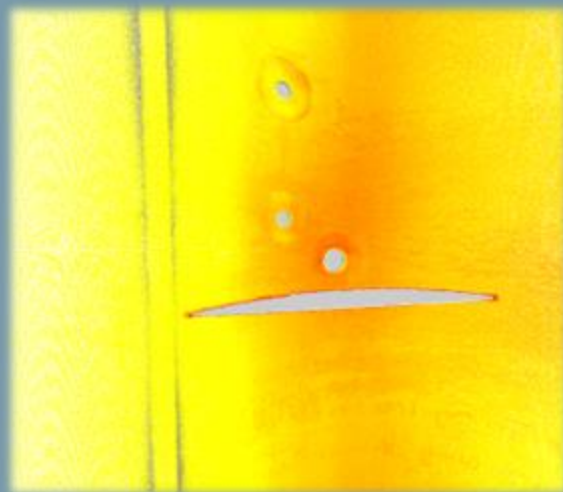
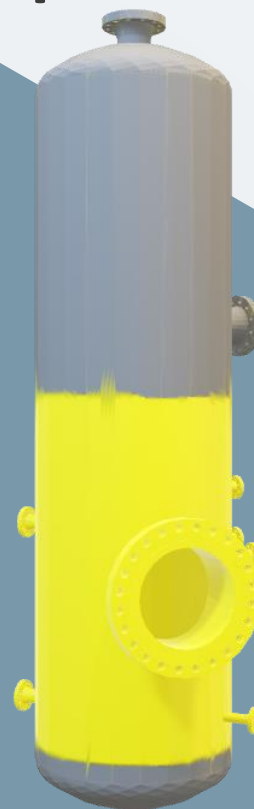
# Laser Scan – Ovality – Test Separator

An attempt was made to determine the vessel ovality

Difficult to quantify with certainty due to noise

A vessel with a less reflective surface would have produced more favourable results

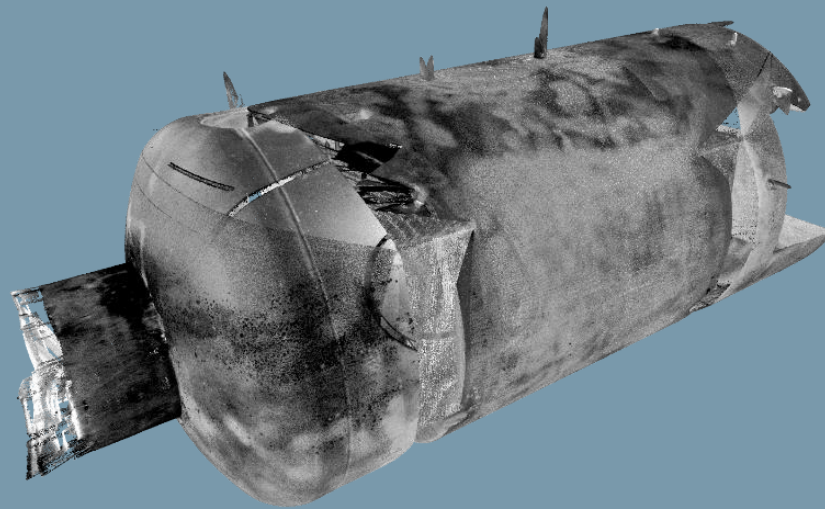
# Laser Scan – 3D Model – Tilted Plate Separator

Laser scanning more successful than the Test Separator with measurement of pitting possible

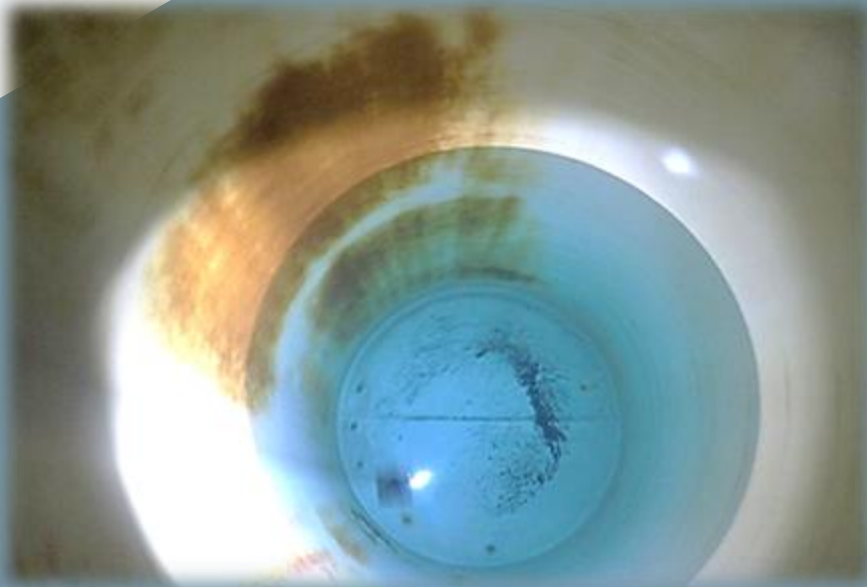
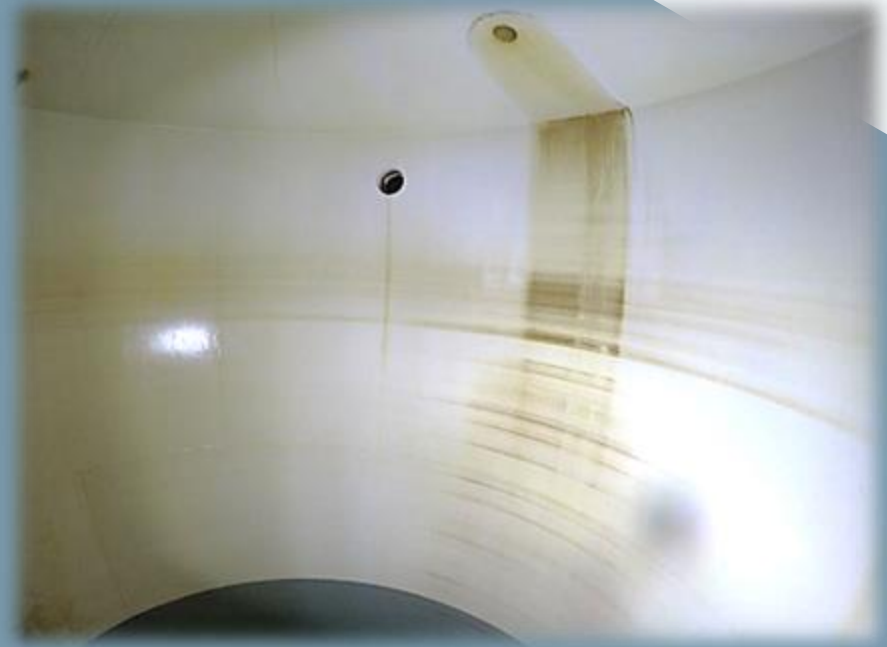
# Results – Potable Water Tank

GoPro imagery was more than adequate

Imagery used to scope Fabric Maintenance scope

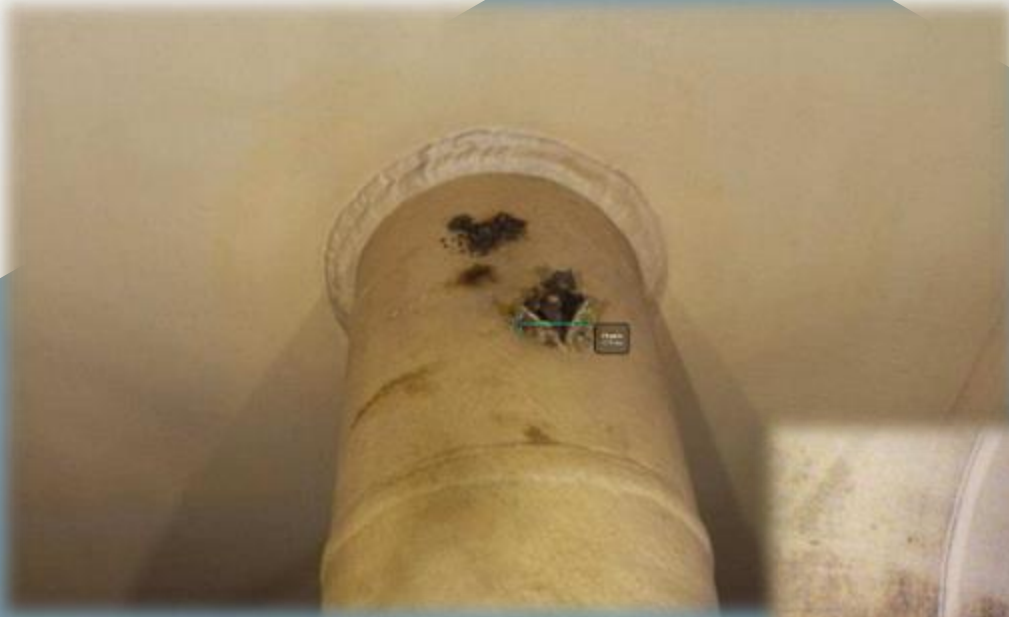
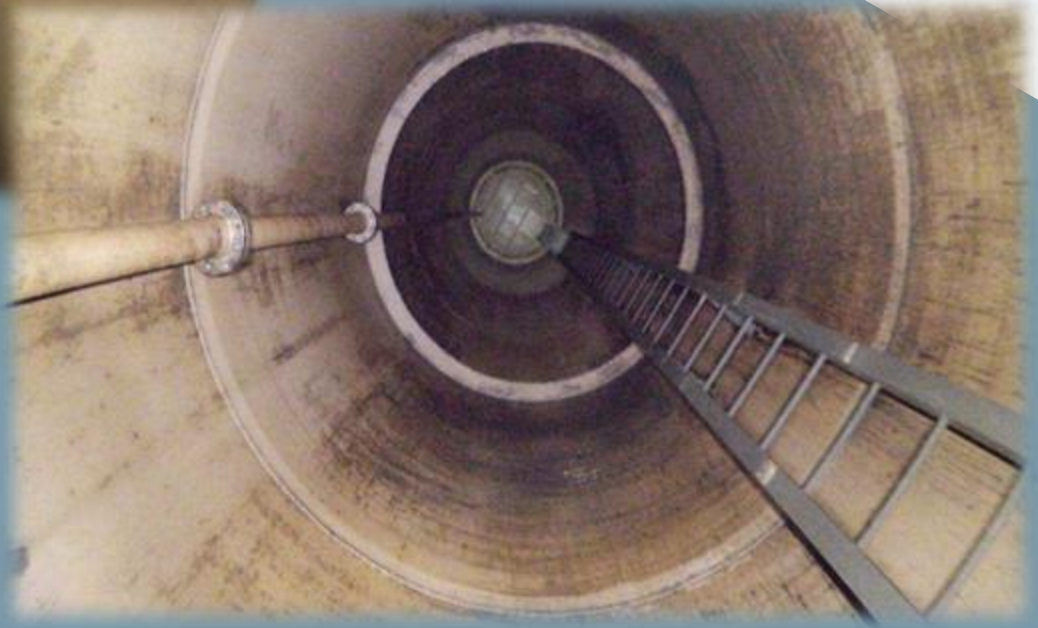
# Results – Diesel Tank

Clear imagery with ability to size defects
