# RSRUK – Technology Network

Tuesday 29<sup>th</sup> January 2019, 1-4pm, OGA Aberdeen and London

## RSRUK – Non Intrusive Inspection

## RSRUK – Case Study (Claymore Production Separator)

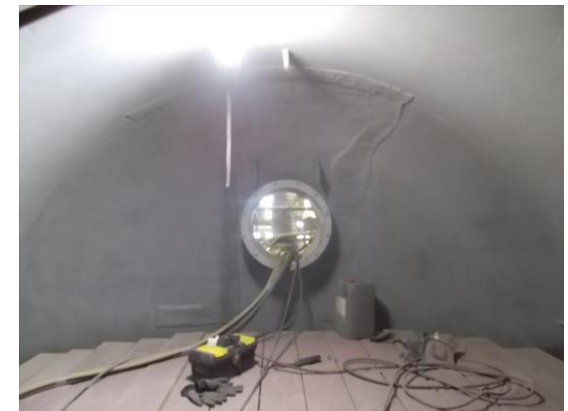
Internal visual  
Inspection Verified  
this internal wall loss  
and also measure  
wall thickness down  
to 11.5mm.

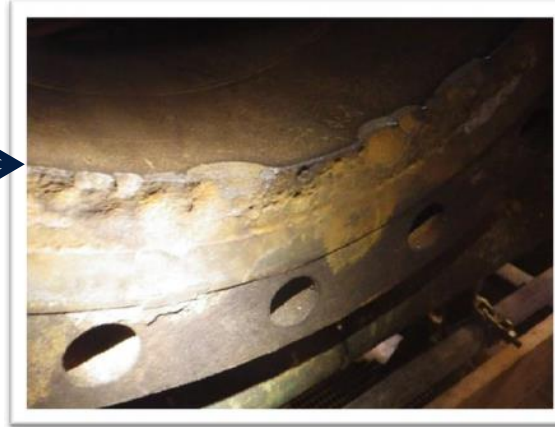
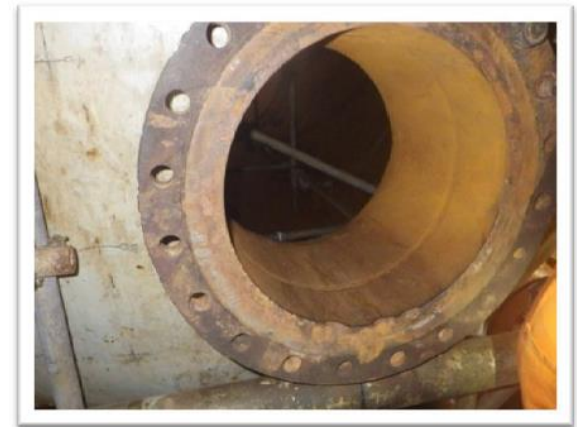
## Nozzle Flange Faces/ Shell Restrictions

Not a Non Intrusive method available to determine flange face corrosion.

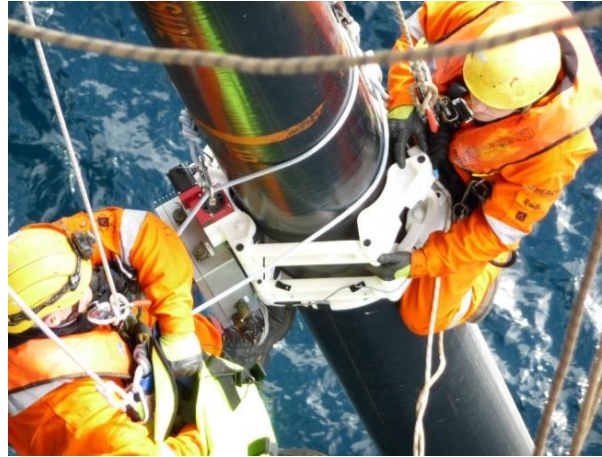
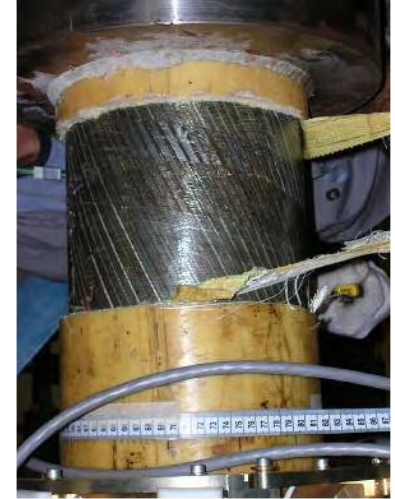
## Application to Flexible Risers

- ▶ For flexible pipelines this is achieved by inducing a magnetic field the armour wires at different internal pressures and then measuring the resultant magnetic signature at each pressure
- ▶ It is usually deployed from topsides

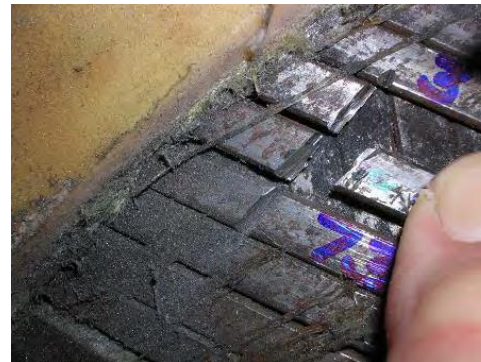
- ▶ A non-loaded (i.e. broken) armour wire can therefore be detected relative to other wires

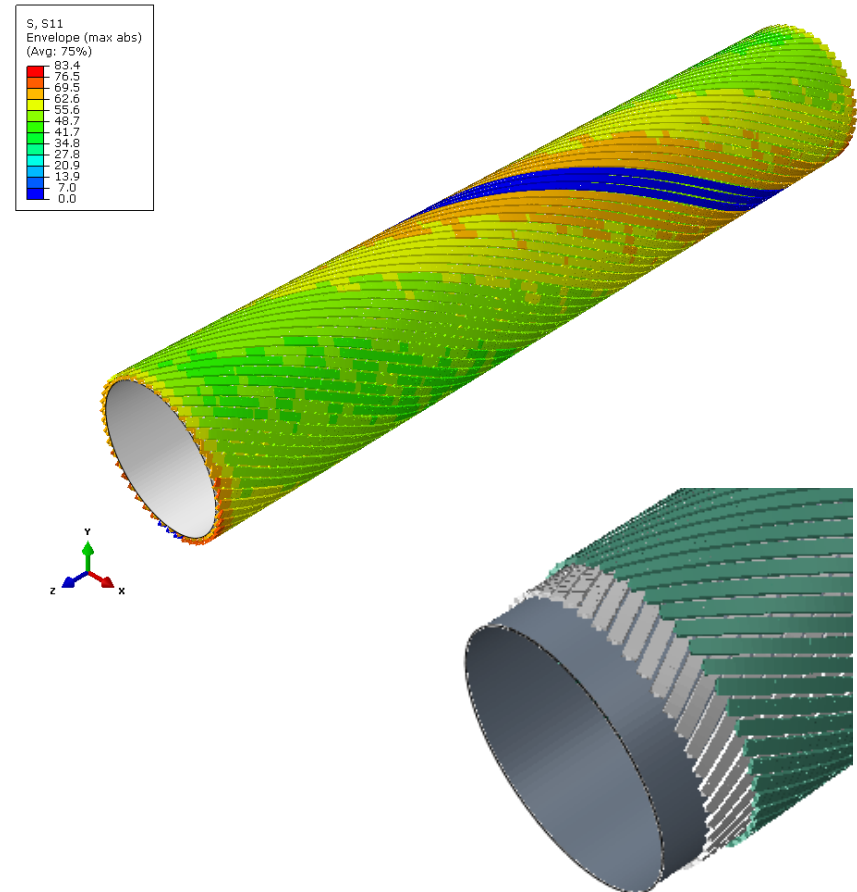
## Results

- ▶ RSRUK trial of the MAPS inspection reported a riser that had one unloaded outer tensile armour wire
- ▶ This will subsequently require replacement
- ▶ Risers where no loss of tension was detected can be subject to justified life extension.
- ▶ The cost of deployment was around £1.5m for 5 risers.
- ▶ When being deployed subsea the application is very weather dependant.
- ▶ Requirement to increase and decrease pressure whilst tool is in place.
